TITLE: Exploratory Investigation of Failure Mechanisms in Transition Regions Between Solid Laminates and X-cor Truss Sandwich

Exploratory investigation of failure mechanisms in transition regions between solid laminates and X-cor[®] truss sandwich

T. Kevin O'Brien ^{*,1}, Isabelle L. Paris ²

NASA Langley Research Center, Mail Stop 188E, Hampton, VA 23681-2199, USA

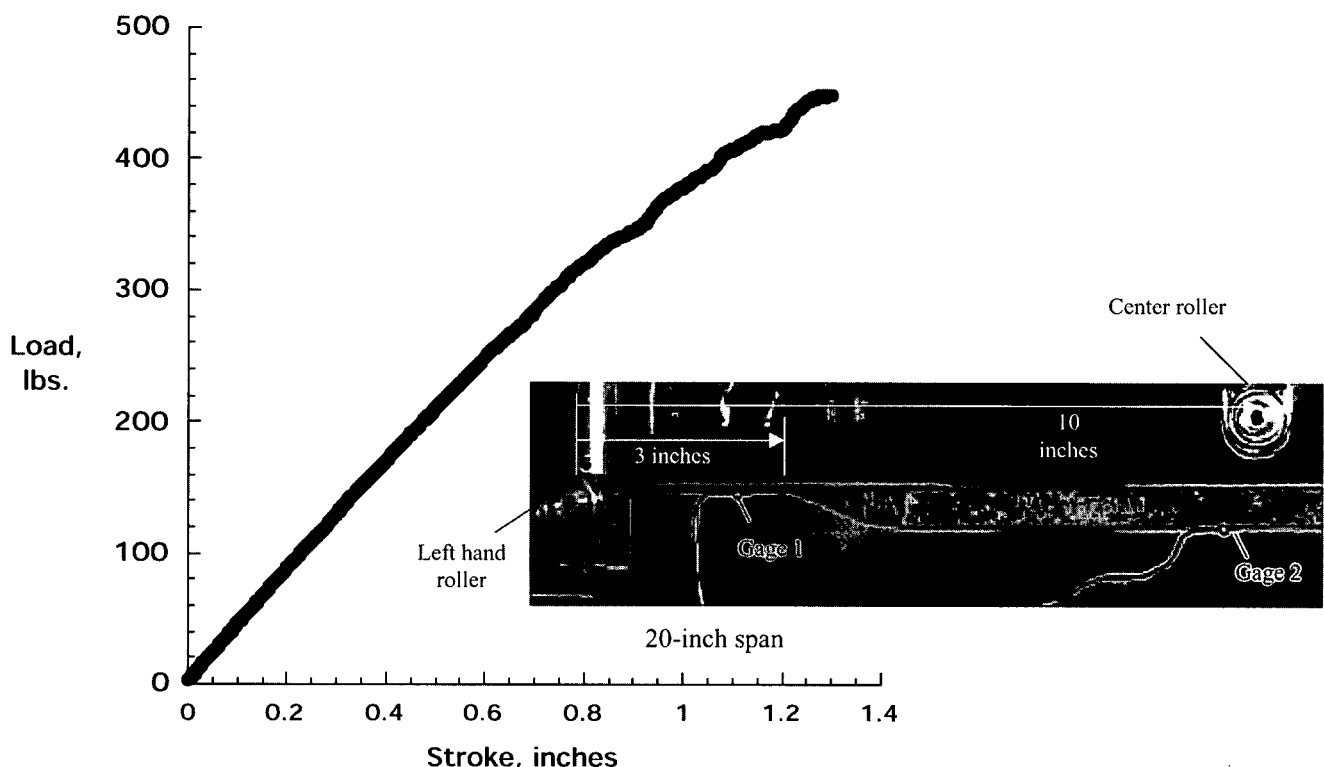
Fig. 2. X-cor® truss specimen load vs. stroke response under three-point bend loading.

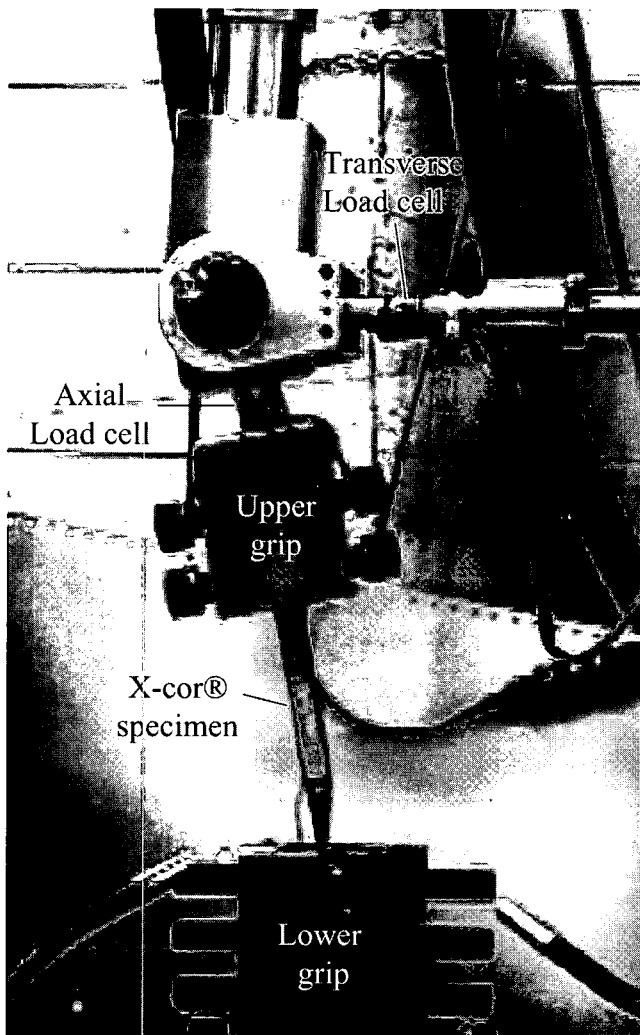
Fig. 4. ATB and X-cor® specimen.

These combined loading tests were performed on the ATB machine at NASA Langley. Fig. 4 shows the X-cor® truss specimen loaded in the ATB. Fig. 5 shows the axial and transverse loading that was applied to these specimens. A digital video camera was used to capture the overall deformation and sequence of final failure. A high-resolution digital camera was used to take close up photos of the pin behavior in the transition region during holds in the loading.

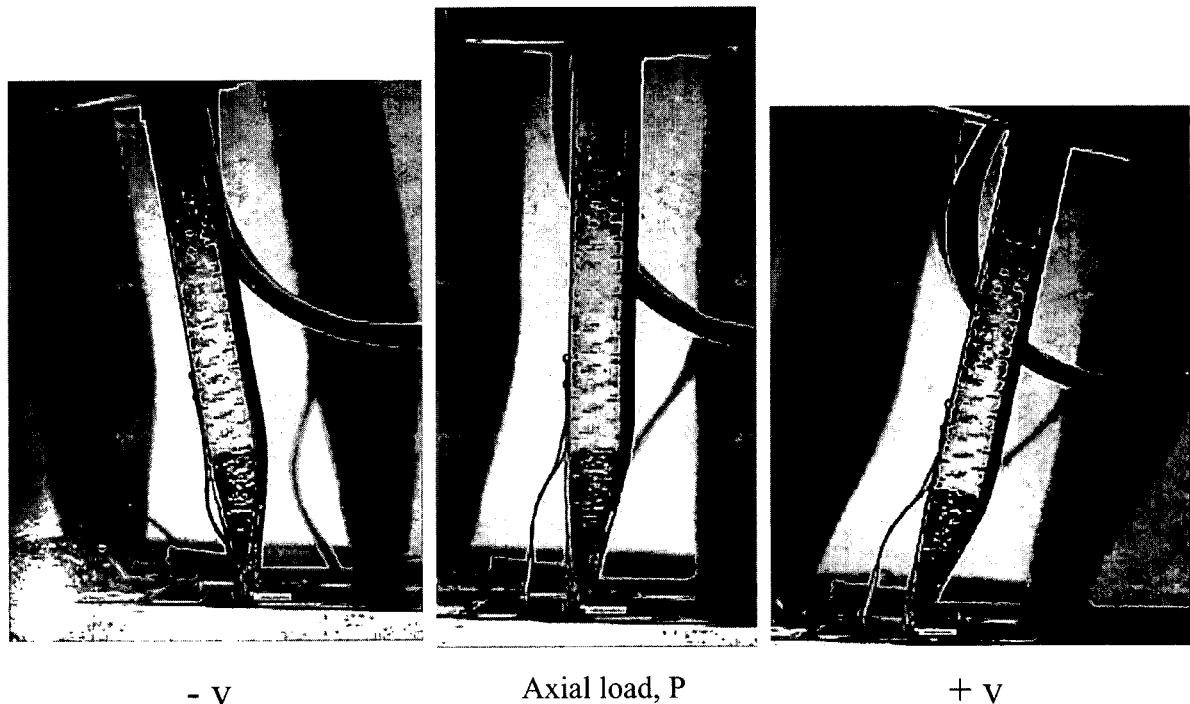
Fig. 5. Details of specimen loading in ATB test machine.

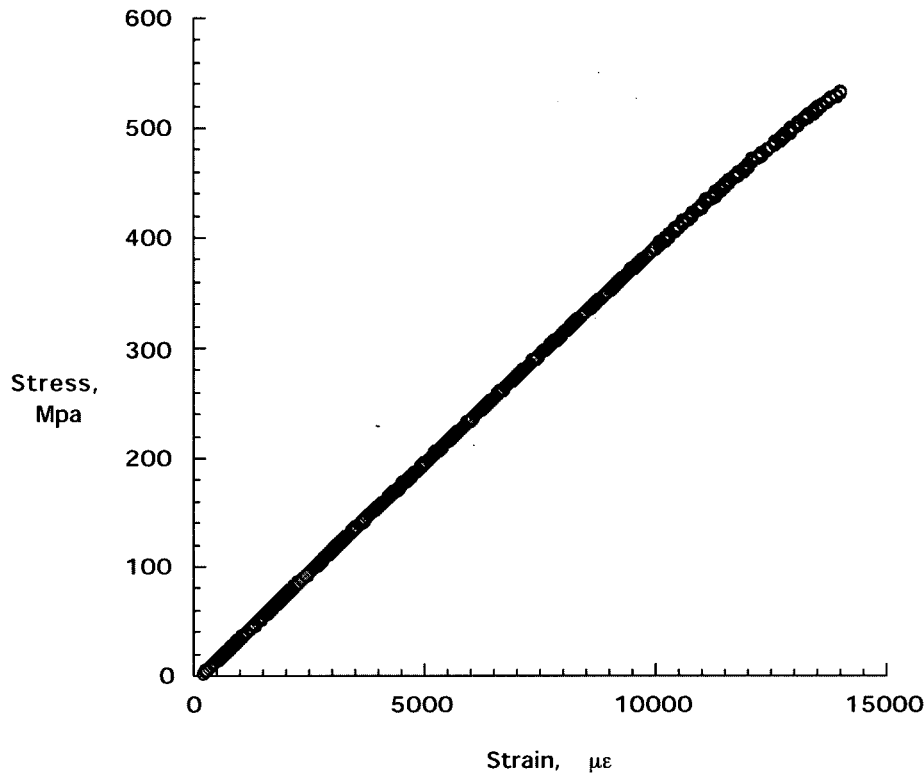
Fig. 6. Typical tension stress-strain response for solid laminates.

Fig. 6 shows a typical tension stress–strain response for the skin laminates. Data obtained from these tests are summarized in Table 4. These data were used to anticipate skin failure strains for the following sandwich laminate tests.

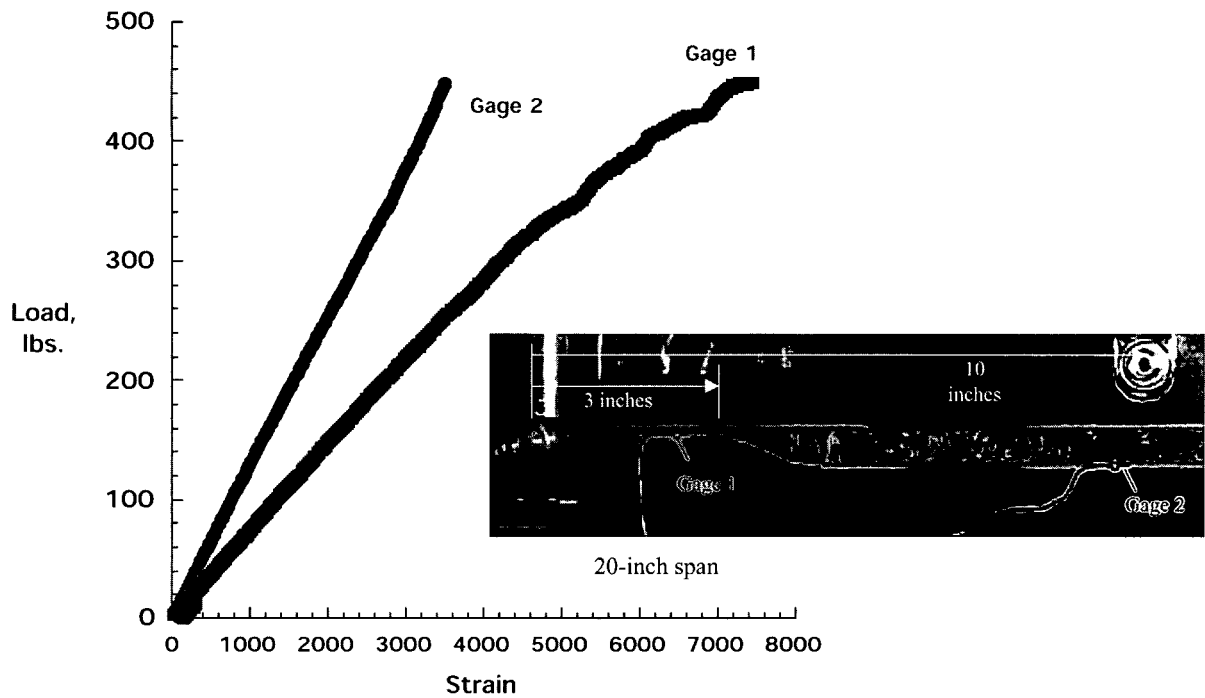
Fig. 7. X-cor® truss specimen load vs. strain response under three-point bend loading.

Fig. 7 shows the load vs. strain response for the three-point bending test. Because of the large span of the stiff sandwich region, most of the deformation occurred in the solid laminate regions on either end of the specimen. The test was terminated when the specimen slipped off of the left-hand roller. At this point, strain gage #1 had reached almost $7500 \mu\epsilon$. However, this was only half the failure strain of the solid laminate as determined by the solid laminate tension tests (Fig. 6). The deflection in the skin laminate was quite large, and the center load nose stroke was nearly 1.5 in. Several pings were heard during the loading. These were documented on the digital video taken during the test with a digital video camera.

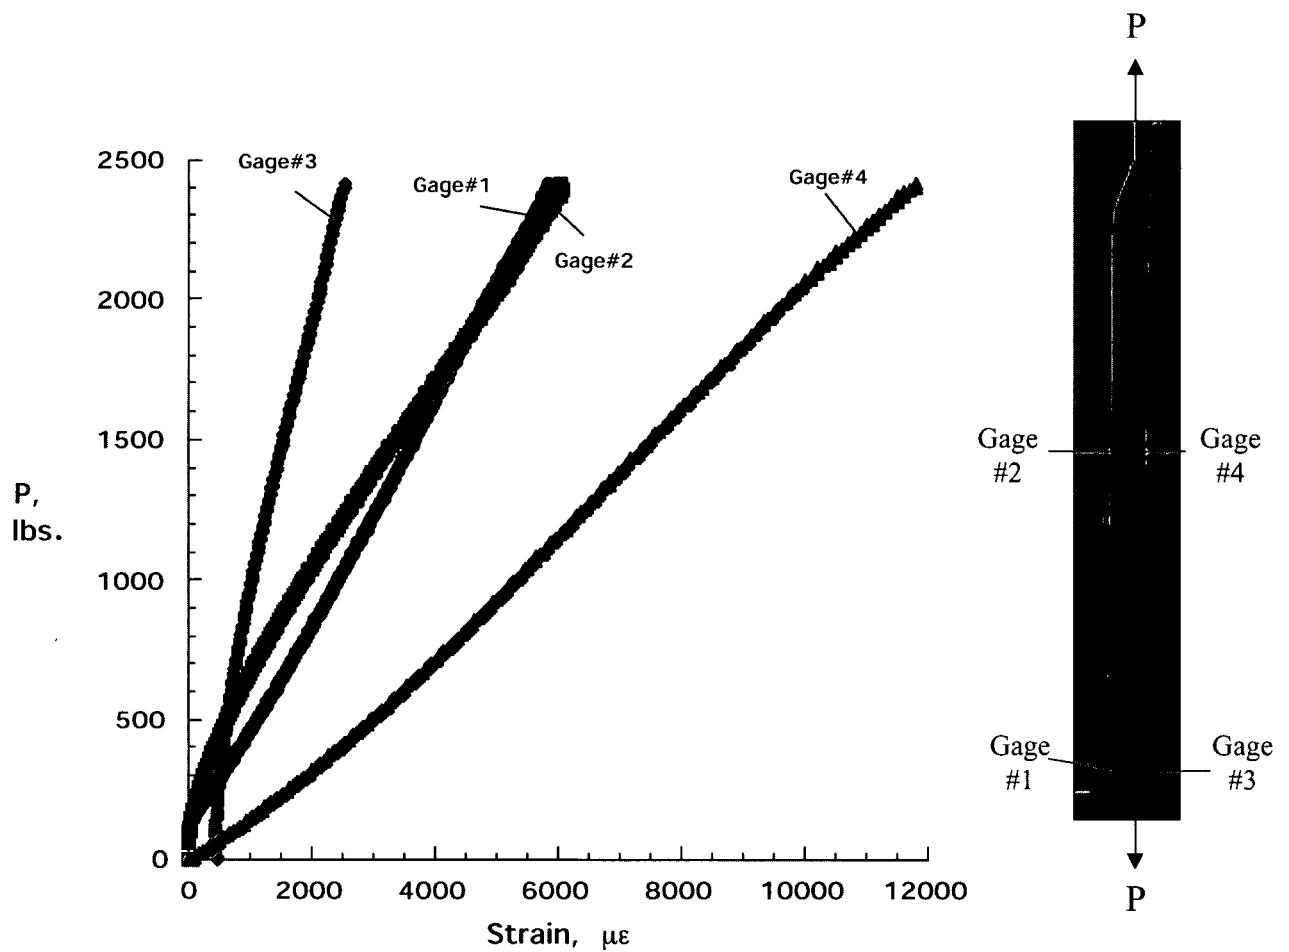
Fig. 8. Load vs. strain response for full-length X-cor® truss sandwich tension test.

Fig. 8 shows the load vs. the strain gage outputs for the full-gage length test. The gages were zeroed before

clamping in the lower grip, so some gages read small compressive strains at the start of the test. The highest tensile strain throughout the test was indicated by gage #4, located on the back of the sandwich in the middle of the gage length. The video indicated that this is the tension side of the bending in the sandwich region. The video of the full-gage length clearly showed the bending induced by the eccentricity of the load path. However, the solid laminate region exhibited bending in the opposite direction, with gage #1 showing more tension strain than gage #3 (Fig. 8). This was also evident in the video of the local transition region.

The first “ping” indicating pin debonding occurred at 1250 lbs, with $6500 \mu\epsilon$ indicated by gage #4. This pinging continued to occur as the load was increased. However, the frequency of the pinging exceeded any visual observations of pin debonding in the video of the transition region. Final failure was at 2410 lbs, with close to $12,000 \mu\epsilon$ indicated by gage #4. This was within the range of failure strains (9000 – $15,000 \mu\epsilon$) recorded in tension tests on the solid laminates. The specimen failed in the skin near gage #4, accompanied by separation of the sandwich core from the back skin and by delamination between the top skin and bottom skin at the transition region.

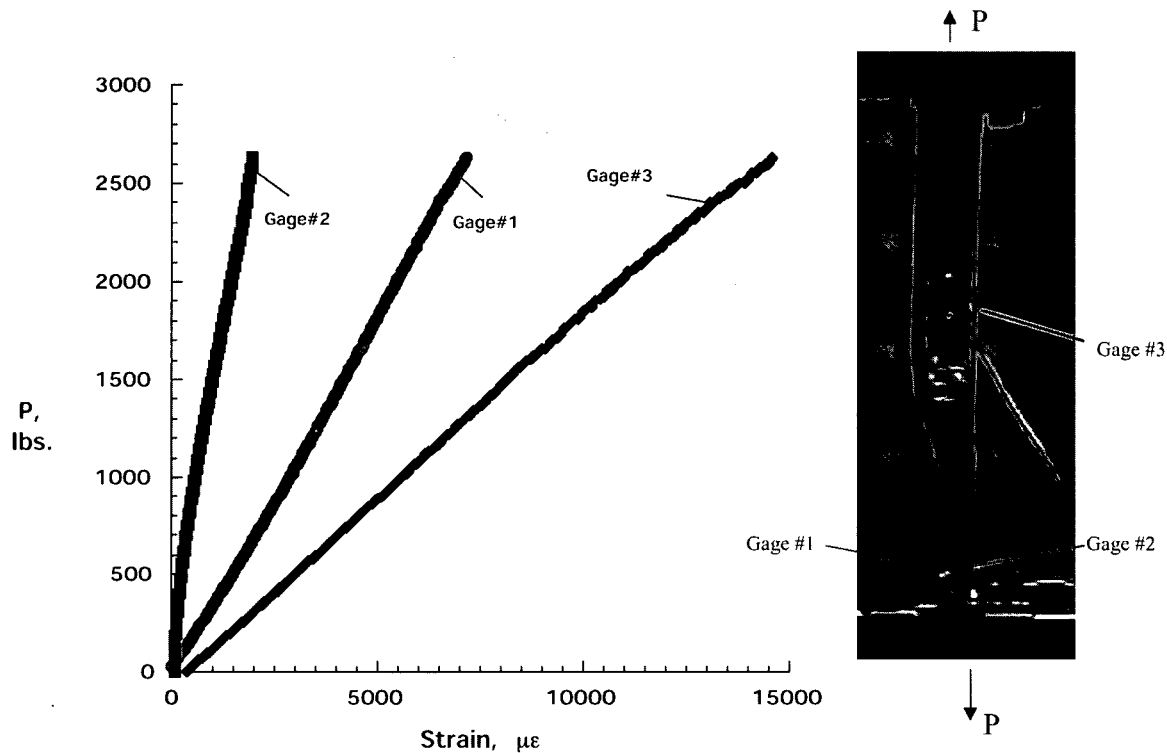
Fig. 9. Load vs. strain response for half-length X-cor® truss sandwich tension test.

Fig. 9 shows load vs. the three strain gage outputs for the half gage length test. The load–strain response was similar to the full-gage length test, except that the maximum strain achieved was slightly higher. The video

of the half gage length showed the bending response induced by the eccentricity of the load path. As noted for the full-gage length test, gage #1 mounted on the transition side of the solid laminate indicated more tension strain than gage #2 on the opposite side (Fig. 9). This was also evident in the video of the local transition region.

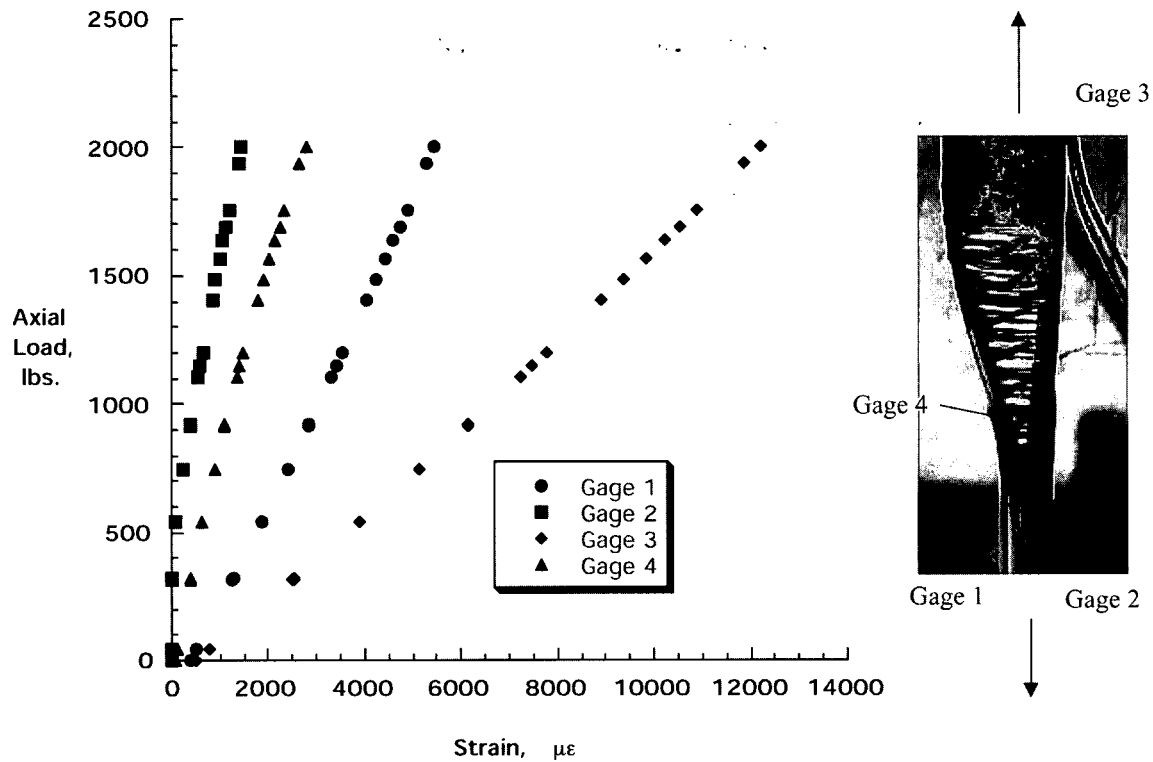
Fig. 11. Axial load vs. strain response for ATB X-cor[®] sandwich specimen #1.

Fig. 11 shows the axial load vs. strain gage data for specimen #1 recorded during loading sequence 3. As noted previously in the tension tests that were run to failure, the maximum strain was indicated by gage #3. Gage #4 was added to the ATB test specimens because the previous tension tests, that were run to failure, indicated that the failure might have initiated in the skin at this location. However, the strains recorded in gage #4 were considerably lower than indicated by gage #3.

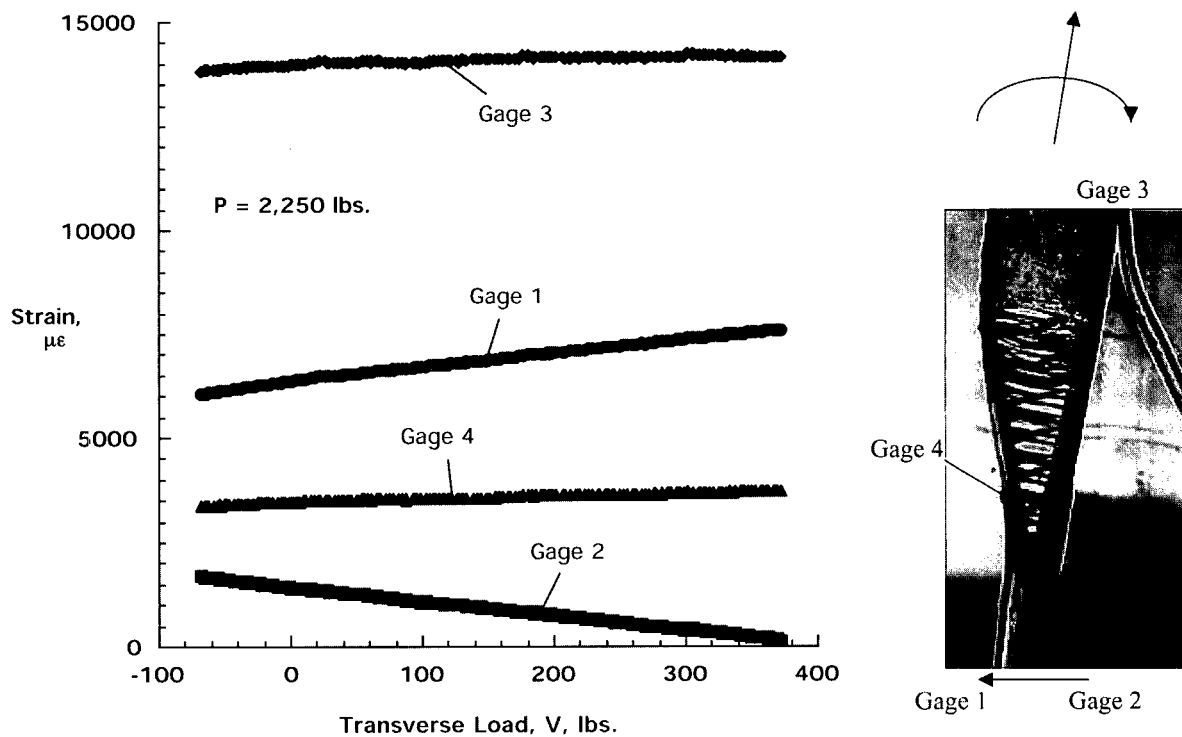
Fig. 12. Strain vs. transverse load response for ATB X-cor[®] sandwich specimen #1.

Fig. 12 shows the strain vs. transverse load response for specimen #1 recorded during loading sequence 3. The axial load was held constant at 2250 lbs during the transverse loading. Gages #1 and #2 show the anticipated bending response due to the bending moment

generated near the lower grip. However, the strain levels in the skin laminate measured by gages #1 and #2 are considerably lower than that in gage #3. Also, the bending load increases the strain in the core skins at gages #3 and #4, but only by slightly more than the axial loading alone. The highest strain indicated by gage #3 prior to specimen failure was 14,195 $\mu\epsilon$.

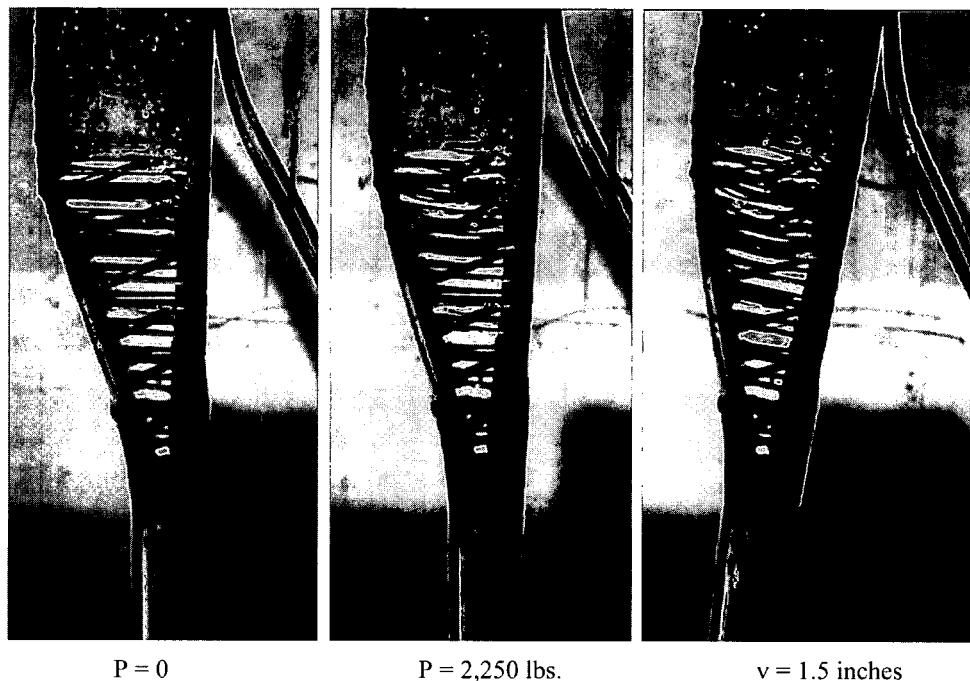
Fig. 13. Pin buckling in ATB X-cor[®] sandwich specimen #1 subjected to tension and bending.

Fig. 13 shows the high-resolution digital images taken during sequence 3 loading. The left image was taken when the specimen was unloaded ($P = 0$). The second image was taken when the maximum axial load was applied ($P = 2250$ lbs). The third image was taken when the transverse stroke was 1.5 in. The greatest change occurred during application of the axial load. The pinging corresponded to pins debonding and/or buckling due to the through-thickness Poisson contraction of the specimen. This buckling continued to a much smaller extent as the transverse load was applied. It was not evident if this pin buckling could occur in the core regions if the foam was intact.

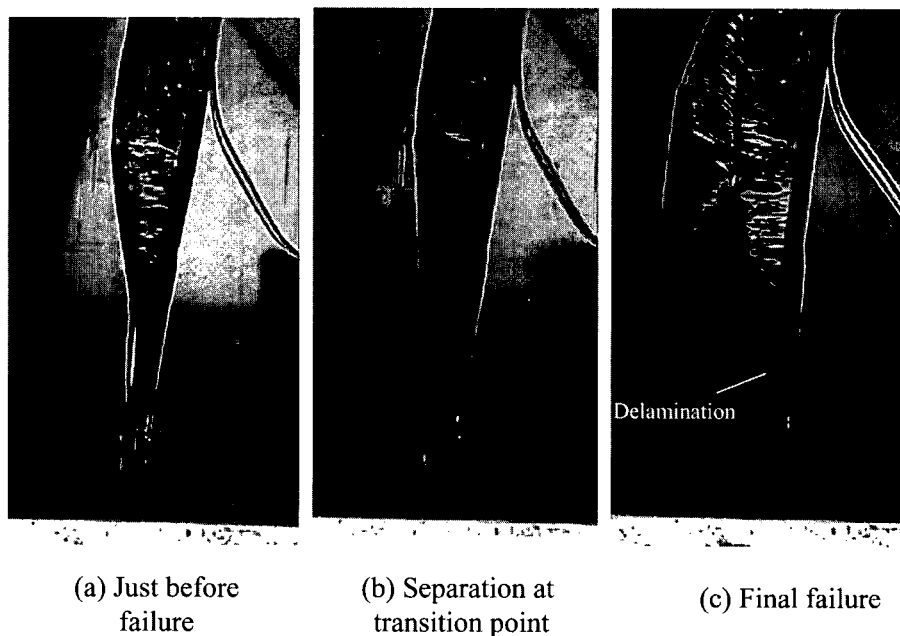
Fig. 14. Failure sequence for ATB X-cor[®] truss sandwich specimen #1 loaded in tension and bending, sequence 3: (a) just before failure, (b) separation at transition point, and (c) final failure.

Fig. 14 shows the failure sequence in specimen #1, captured by the digital video camera during sequence 3. The middle frame clearly indicated that the failure initiates as a separation of the skin laminates at the transition region between the solid laminate and the X-cor® truss. The final frame shows the delamination that grew into the solid laminate as a result of this separation. Once this has occurred the skin laminate fails on the

right side. The failure went through gage #3. This may also have been the failure sequence in the previous tension tests run to failure, as opposed to an initial skin failure at the location of gage #4 as previously expected.

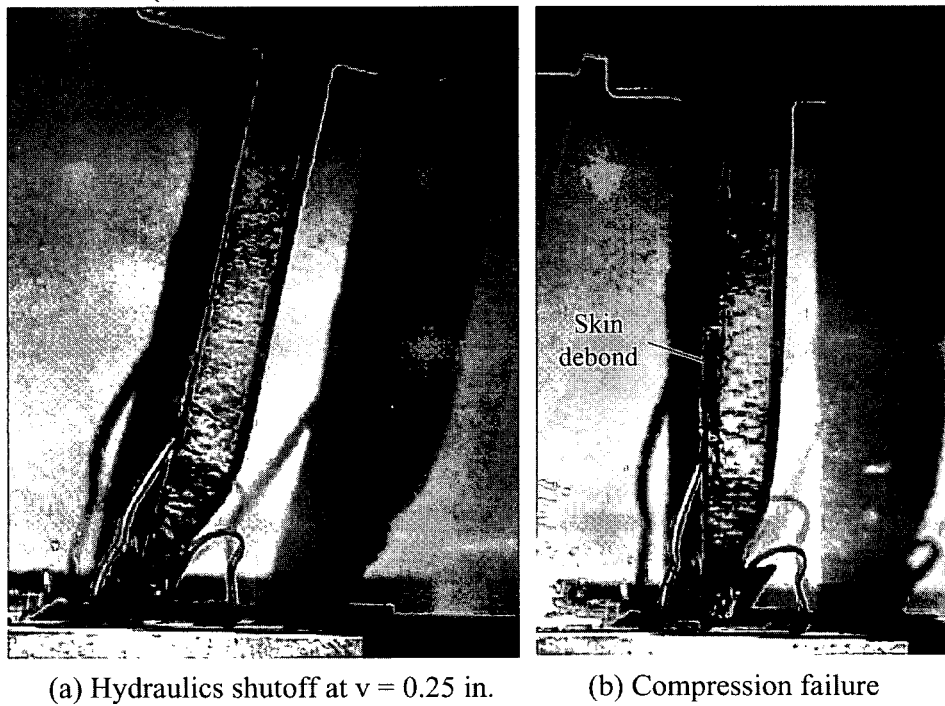
Fig. 15. Failure mode for accidentally failed ATB X-cor® sandwich specimen #2: (a) hydraulics shut off at $v = 0.25$ in. and (b) compression failure.

Fig. 15(a) shows the compression deformation on specimen #2 immediately following the loss of hydraulic power, Fig. 15(b) shows the debonding of the skin from the core that occurred following the compression loading that was accidentally applied when trying to remove the specimen from the machine. This accidental failure illustrates the sensitivity of the X-cor® sandwich construction to compression where failure may occur without a skin fracture. Unfortunately, there was no record of how much compression was accidentally applied to this specimen.

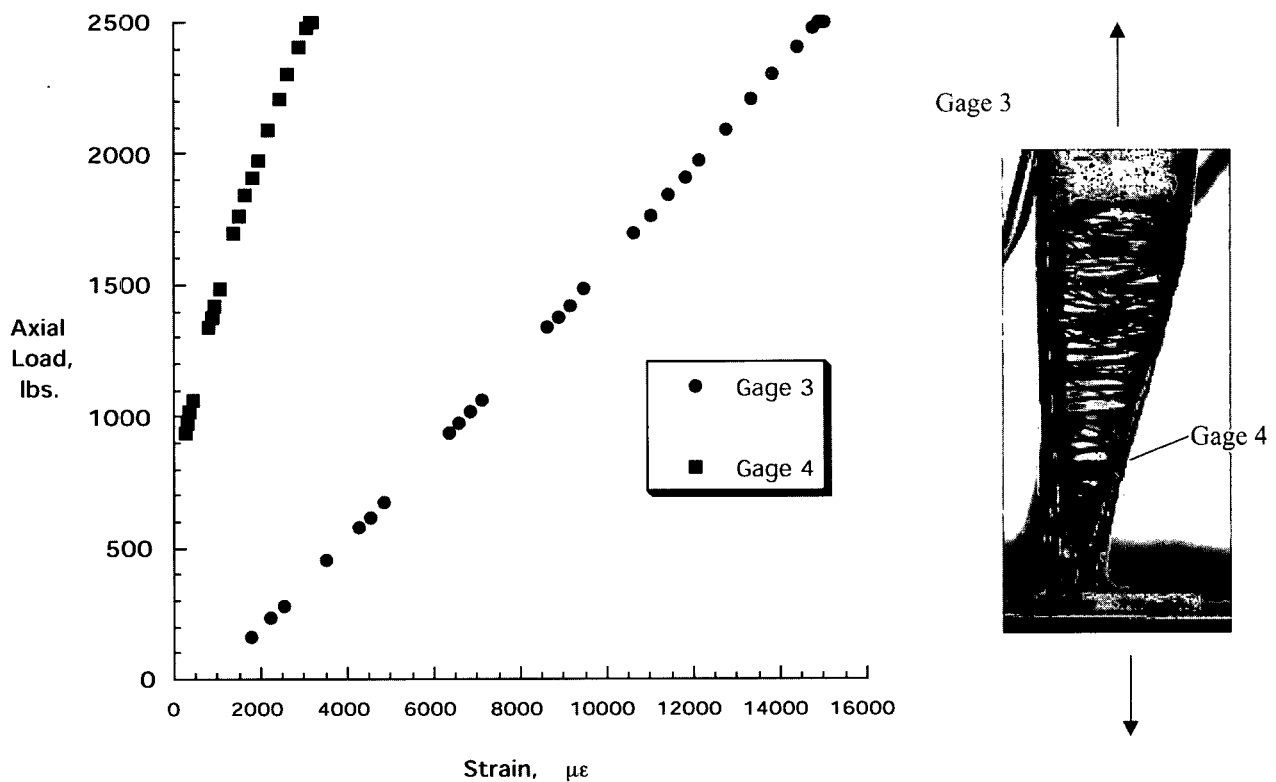
Fig. 16. Axial load vs. strain response for ATB X-cor® sandwich specimen #3.

Fig. 16 shows the axial load vs. strain gage response for specimen #3 recorded during loading sequence 3. As noted previously in the tension tests that were run to failure, the maximum strain was indicated by gage #3. Gage #4 was added to this test because the previous tension tests that were run to failure indicated that the failure might have initiated in the skin at this location. However, the strains recorded by gage #4 were considerably lower than indicated by gage #3.

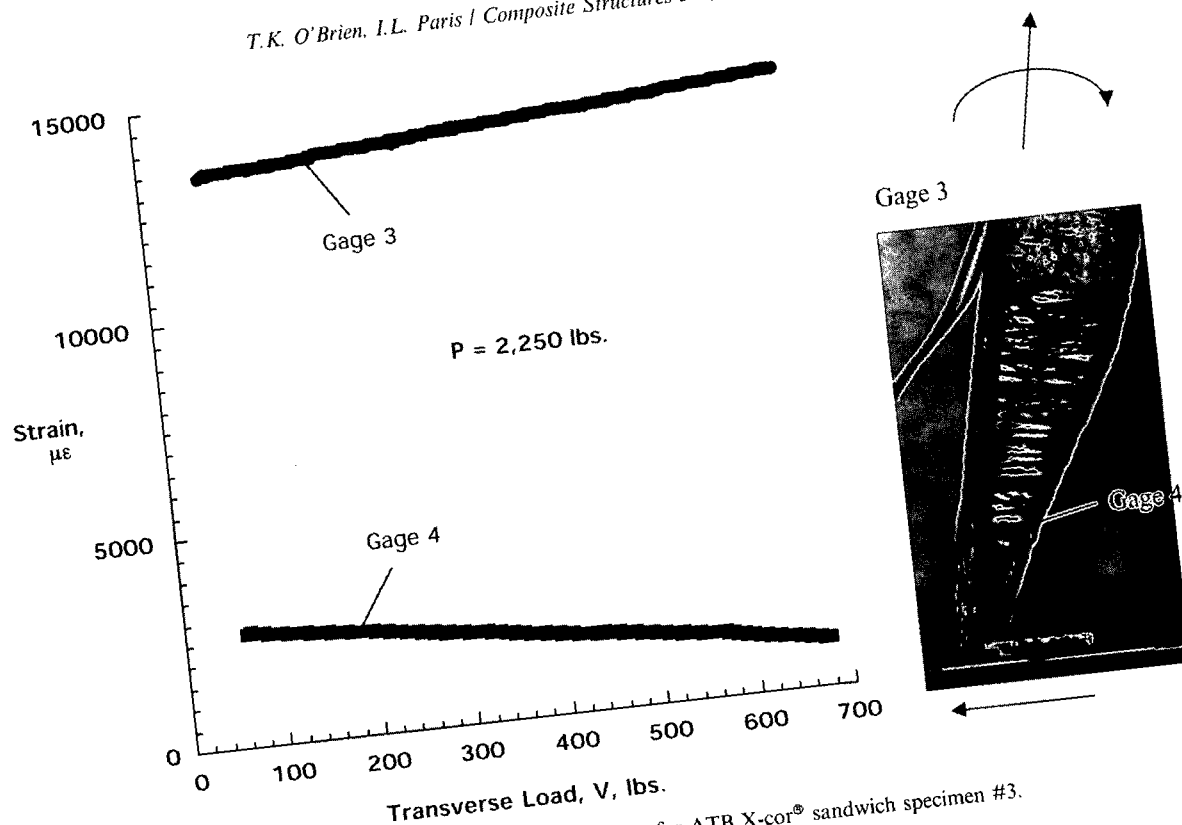
Fig. 17. Strain vs. transverse load response for ATB X-cor® sandwich specimen #3.

Fig. 17 shows the strain vs. transverse load response for specimen #3 recorded during loading sequence 2. The axial load was held constant at 2250 lbs during the transverse loading. The bending load increased the strain in the core skins at gage #3 location. The highest strain obtained indicated by gage #3 during sequence 2 was $14,535 \mu\epsilon$. The strain at failure recorded at gage #3 from sequence 3 soon after transverse loading was applied was $15,200 \mu\epsilon$.

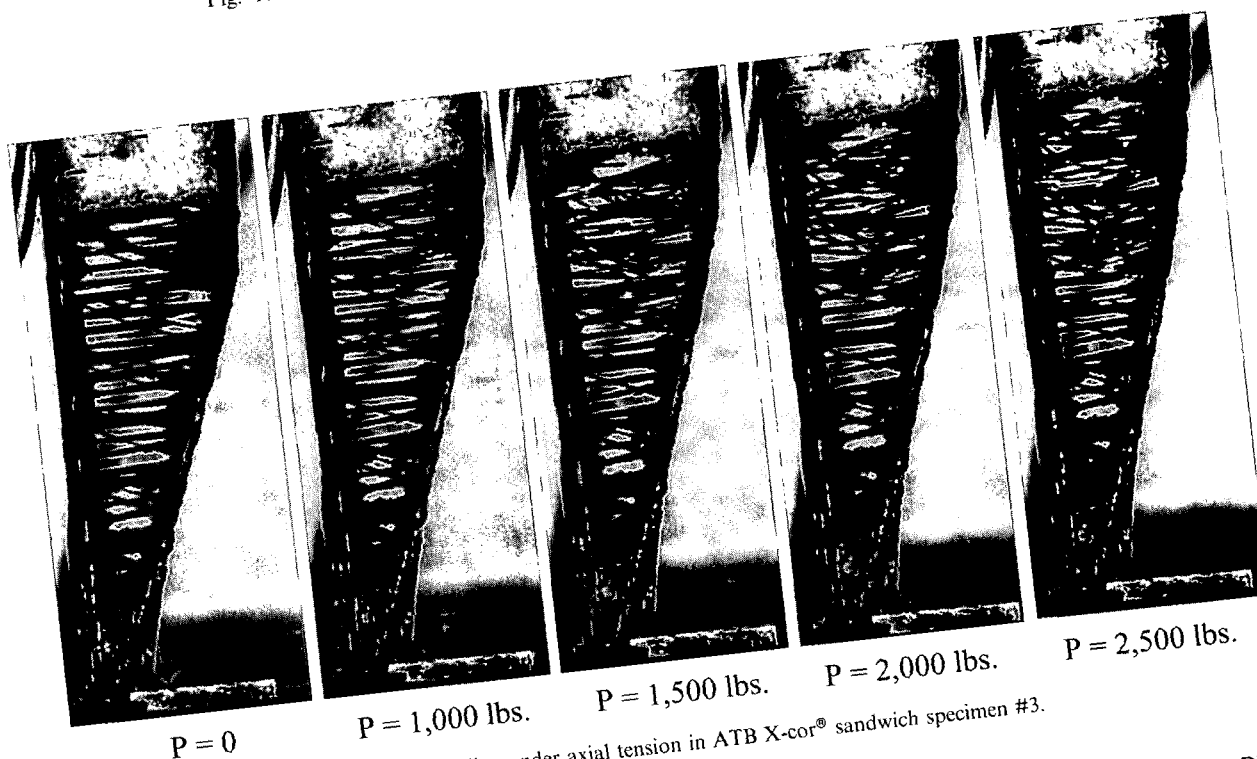
Fig. 18. Pin buckling under axial tension in ATB X-cor® sandwich specimen #3.

Fig. 18 shows the high-resolution digital images of specimen #3 taken during the axial loading in sequence 3. The left image was taken when the specimen was unloaded ($P = 0$). The next four images were taken at increments of axial tension load up to $P = 2500$ lbs. The pinging heard in the video corresponded to pins debonding and/or buckling due to the through-the-thickness Poisson contraction of the specimen. This buckling continued to a much smaller extent as the transverse load was applied. It was not evident if this pin buckling could occur in the core regions if the foam was intact.

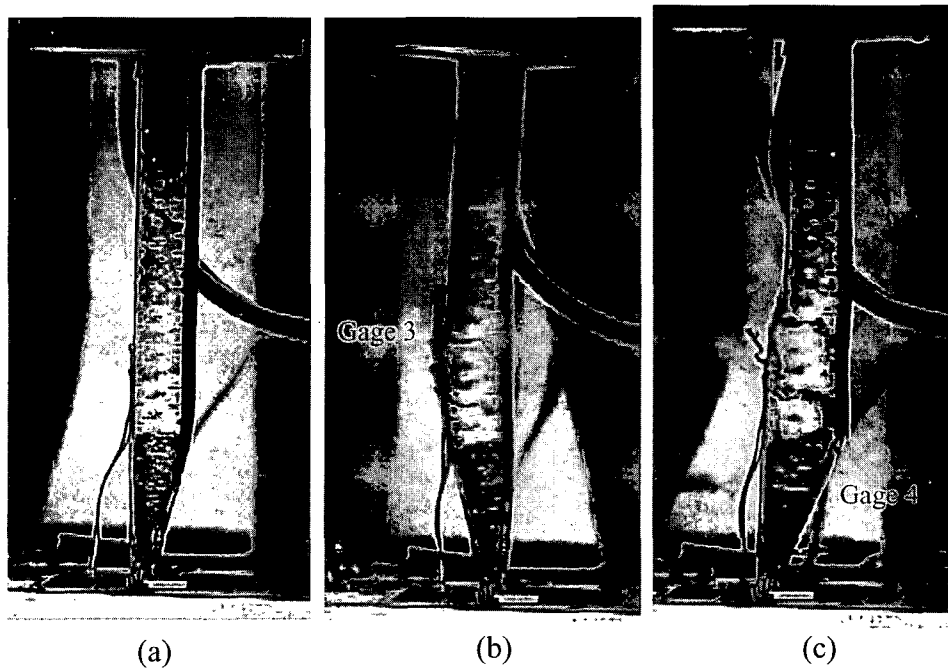
Fig. 19. Failure sequence for ATB X-cor® truss sandwich specimen #3: (a) just before failure, (b) initial failure, and (c) final failure.

Fig. 19 shows the failure sequence in specimen #3, captured by the digital video camera during the transverse loading in sequence 3. The middle frame clearly indicated that the failure initiates as a fracture in the back core skin near gage #3. The specimen did not separate at the transition region between the solid laminate and the X-cor® truss sandwich because the entire skin laminate was in the lower grip. The last frame shows the final failure occurring in the skin laminate on the right side above gage #4. Three separate views of the final failure are shown in Fig. 20.

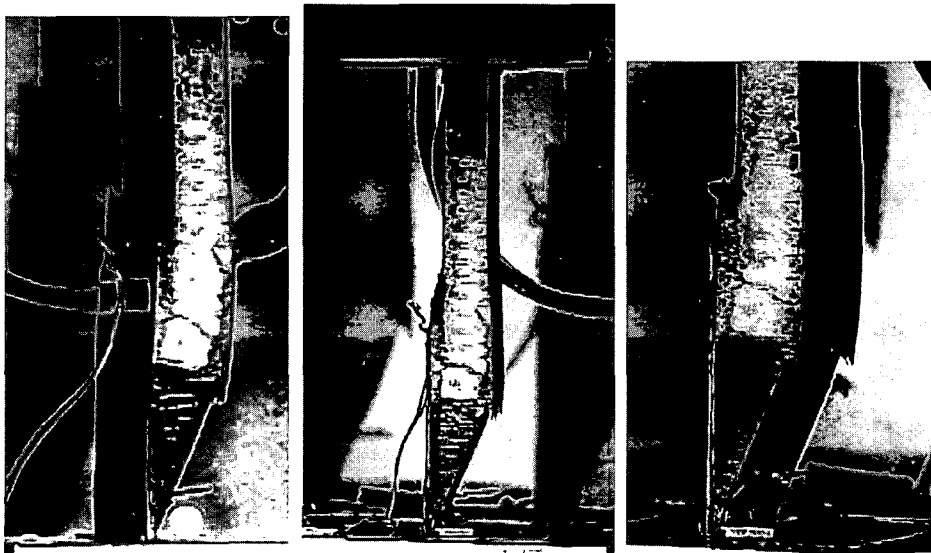
Fig. 20. Failed ATB X-cor® truss sandwich specimen #3.
